# BELZONA REBUILDS AND PROTECTS TURBINE RUNNER HUB

ID: 717

Kaplan Turbine

Hydroelectric Power Plant, France

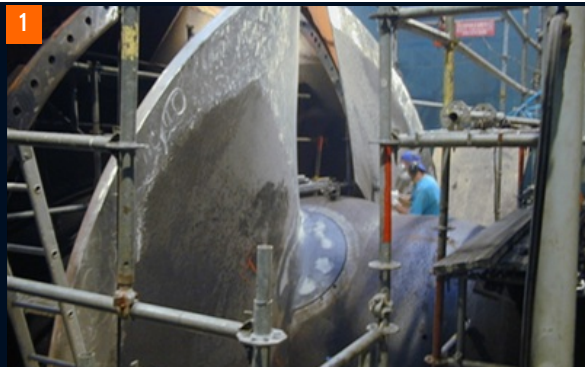
The turbine hub had suffered from erosion due to cavitation.

1. Large Kaplan Turbine
2. Application underway
3. Completed repair and protection
