# BELZONA PUMP CASING REPAIR AND PROTECTION

ID: 718

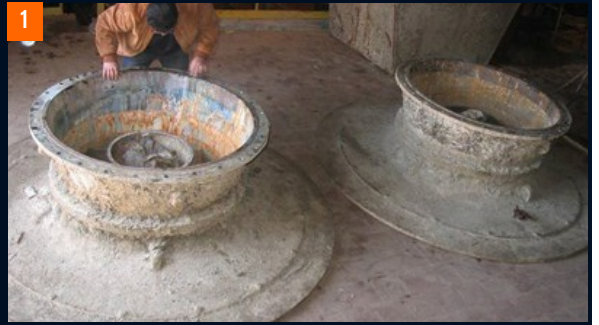
The two casings were deeply eroded and corroded which affected the pressure and the efficiency of the cooling system.

1. The two corroded casings
2. The surface after preparation
3. Rebuilding the surface using Belzona 1311
4. Surface protected with Belzona 1321
