# BELZONA EXTENDS LIFE OF CONDENSER EXPANSION JOINT

ID: 719

The rubber expansion joint of the main condenser of the plant.

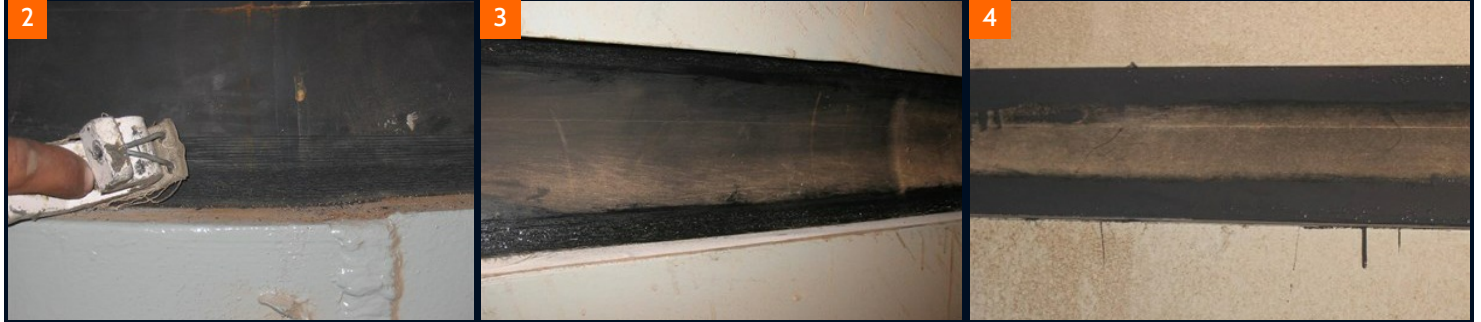
Both sides, top and bottom, of the rubber flexible joint had deteriorated.

1. The deteriorated rubber joint
2. Surface preparation of the joint
3. Conditioning the surface
4. Belzona 2221 applied

Application was carried out in accordance with modified version of Belzona® Know-How System leaflet SHM-9.

Belzona® 2221 was able to quickly and successfully repair the rubber joint on the spot, extending its life without disrupting operation of the plant.
