# BELZONA SAVES RECYCLING DRUM AT PAPER MILL

ID: 72

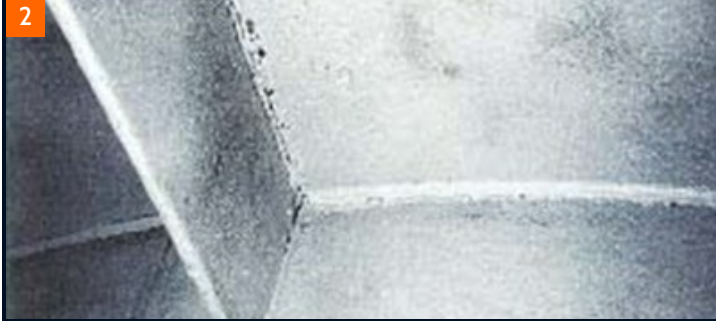
Bi-metallic corrosion on approximately 70% of the weld.

1. Entrance to 30' long and 10' diameter recycling drum.
2. Close-up view of corroded seams.
3. Seam areas rebuilt with Belzona 1311. Entire drum received two coats of Belzona 1321 for erosion/corrosion protection.
