# BELZONA GLAND HOUSING REBUILD

ID: 720

Split casing water pump.

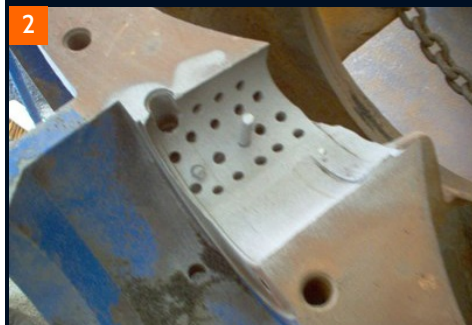
Gland housing of the pump was badly worn and damaged due to mechanical failure.

1. The damaged gland housing
2. Preparing the housing
3. Reforming the housing to its original dimensions
4. Repair completed
