# BELZONA KEEPS IKARUS BUSES ROLLING

General wearing problem on bearing houses and other axle parts.

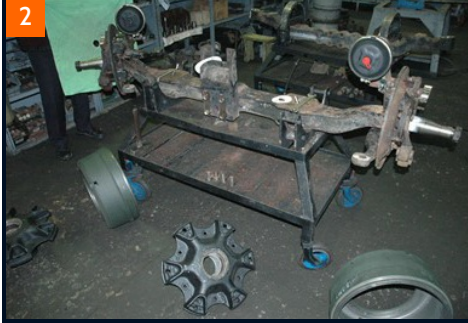
1. Ikarus buses.
2. General view of the axle parts.
3. Belzona 1111 applied.
4. Part of axle after machining.
