# BELZONA OVERCOMES ROOF DESIGN FLAW

ID: 723

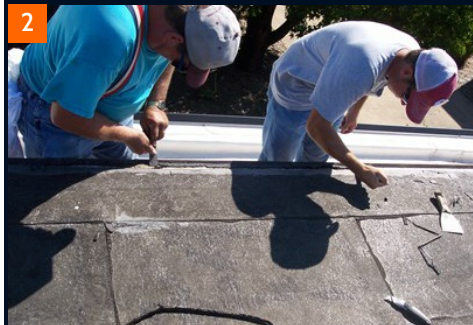
A small collection trough around the 660' perimeter of the roof had mistakenly been "engineered" into the original installation. Water collected and eventually drained under the roof sheets toward the center of the building until it found a leak path onto the ceiling.

1. The poor roof design allowing water to collect and enter
2. Conditioning of metal trim and roof sheet
3. Belzona 3111 being applied through the Reinforcing Sheet
4. Completed application with entire building perimeter sealed with Belzona Membrane System

Application carried out according to Belzona Know-How System Leaflet RPA-1. After surface preparation a fully reinforced Belzona® 3111 system was applied so that it overlapped onto the metal perimeter trim and the main roof covering.
