# RESTORATION OF BRONZE IMPELLER WITH BELZONA

ID: 724

Cooling water pump impeller.

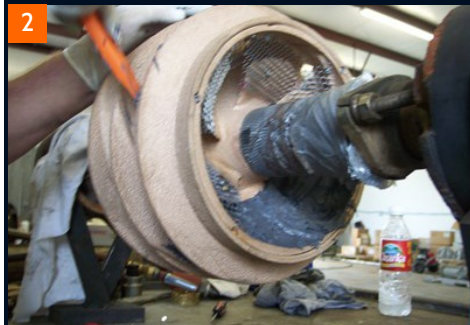
This pump impeller, 1 of 4, normally running 24/7 had eroded to the point of replacement.

1. First inspection showing extent of erosion damage
2. Mesh in place and rebuild proceeding
3. Grinding to contour
4. Rebuilt and ready for service

Application was carried out in accordance with Belzona Know-How System Leaflet CEP-1, CEP-3 and CEP-5. Stainless Steel mesh used to reform vanes. After rebuilding, grinding to original profiles and coating, impeller was re-balanced.
