# CLASSIC PUMP REFURBISHMENT WITH BELZONA

ID: 738

Pump Housing

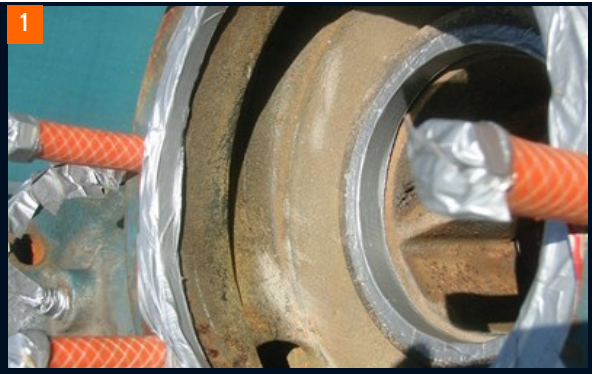
Erosion/corrosion from constant water flow within the pump caused erosion in critical parts of the housing.

1. Rebuilding profiles underway
2. Another view of profiles
3. Completed application

The application was carried out in accordance with Belzona Know-How System Leaflet CEP-2 & CEP-5.
