# BELZONA MANWAY OPENING

ID: 74

Manway opening on chemical storage tank.

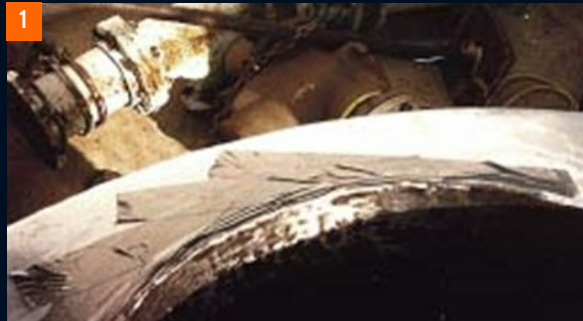
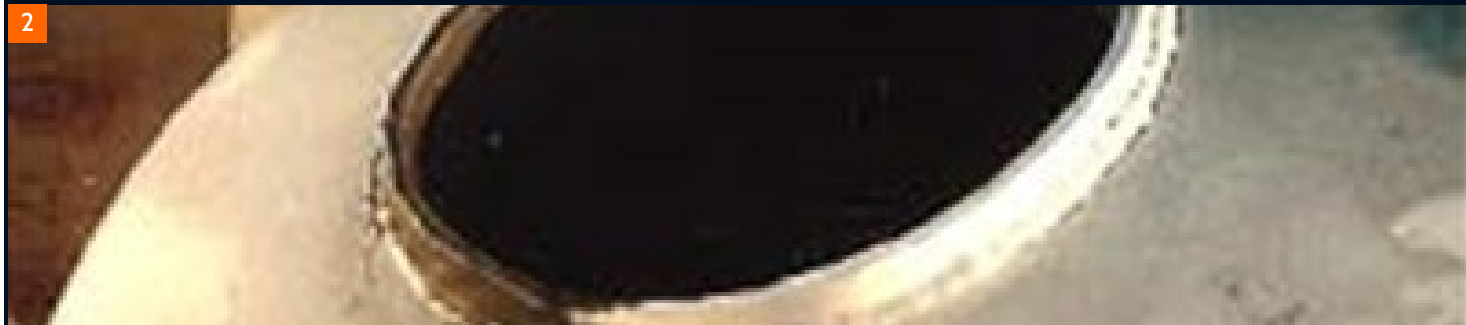
Opening on chemical tank was corroded to the point where a good seal was not possible.

1. Surface preparation performed with the repair area taped off.
2. Manway rebuilt.

The application was carried out in accordance with a modified version of Belzona Know-How Leaflet TCC-10.

For only \$128 in Belzona® 1111 (Super Metal), downtime and expensive welding was averted. The repair has held for many years, and is still in perfect condition.
