# BELZONA REPAIRS RUDDER HOUSING

ID: 7461

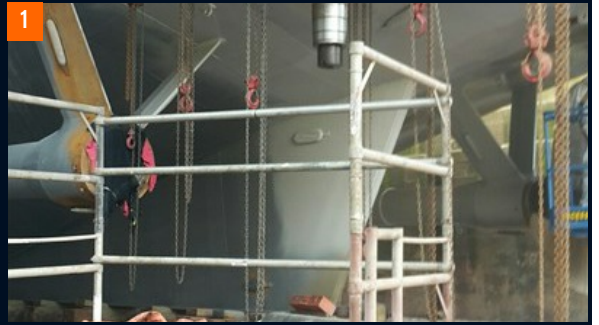
Passenger ferry in dry dock. A becker rudder pintle bush had become loose due to galvanic corrosion. The bush had slipped down the rudder pin & had begun to wear on the housing itself.

- 1- Area to be repaired
- 2- Bush showing large amounts of wear
- 3- Housing before grit blasting
- 4- Bush bonded in & aligned

The application was carried out in accordance with Belzona System Leaflet SOS-9. The bush was machined to give a 5mm clearance. The housing was grit blasted and Belzona 1111 applied to the two parts, then the bush was pressed into position. Care had to be taken to ensure the correct alignment of the piece.

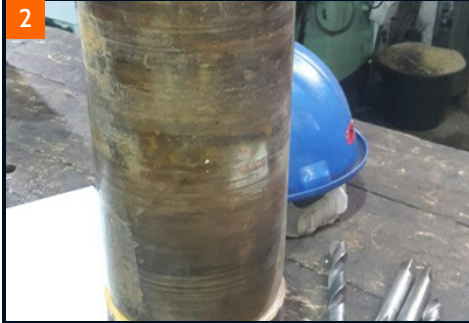
The normal repair method would involve shrink fitting the bush back into place. The erosion/corrosion on the housing & bush was too severe for this method to be used.
