# BELZONA RECOVERS CONCRETE CLEAR WELL AT A 50-YEAR-OLD WATER PLANT

ID: 7464

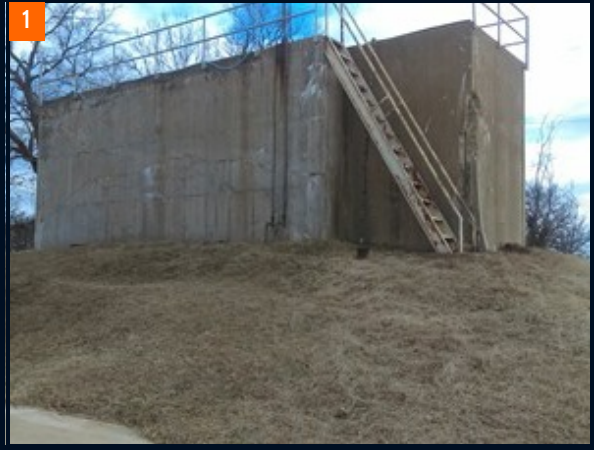
This concrete clear well had 185 linear feet of hairline cracks and corners that were gradually crumbling off as well as exposed rebar.

1. Hairline cracks on the exterior of the concrete wall 2. Concrete surface preparation 3. Injection ports anchored with Belzona 1121 4. Belzona 4141 application
