# POSITIVE FEEDBACK ON BELZONA APPLICATION OF A SECONDARY CLARIFIER

ID: 7465

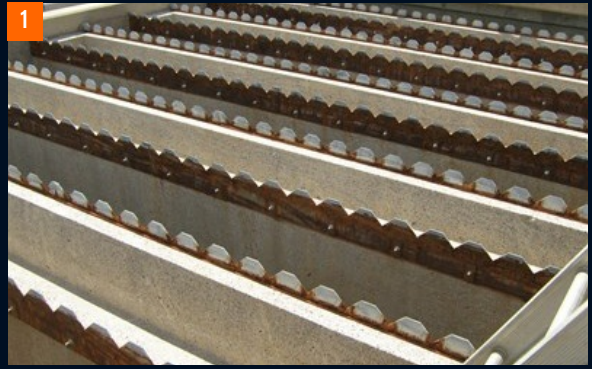
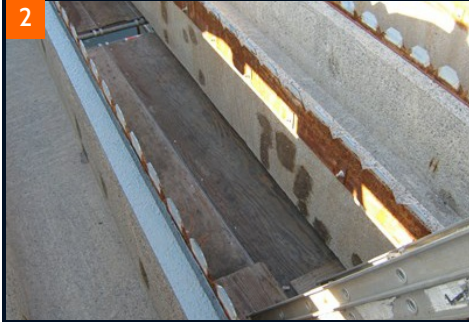
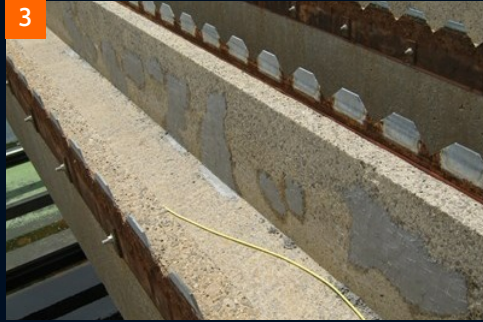
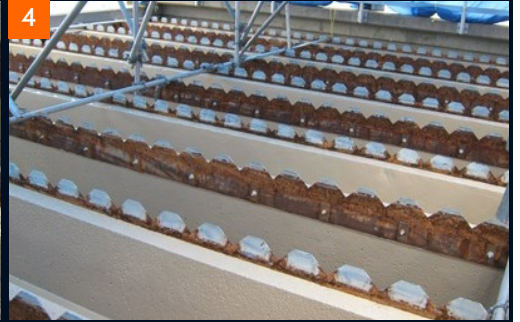
The secondary clarifiers at the Water Pollution Control Center were pitted and deteriorated due to chemical attack from the biological treatment process.

The clarifiers were covered in algae and debris, creating a particular problem during the summer season when the crew usually works on the maintenance program.

The tank was power washed and allowed to dry. Pits, cracks or holes were conditioned with Belzona 4911 and then filled with Belzona 4131 using a trowel. Once repaired, Belzona 5811 was applied to the entire internal part of the tank with rollers and brushes.

Belzona helped get the tank back in production, helping the entire city of Sarnia. After 6 years, we received feedback from the Maintenance Mechanic of the facility: "Belzona 5811 has been holding very well and will contact the city about budget to move forward to coat the rest of the secondary tanks with Belzona solutions". A second inspection was carried out in April 2024 and the coating is still holding well and protecting the weirs
