# BELZONA PROTECTS OF 10 " AND 3 " VALVES ON THE COAST

ID: 7468

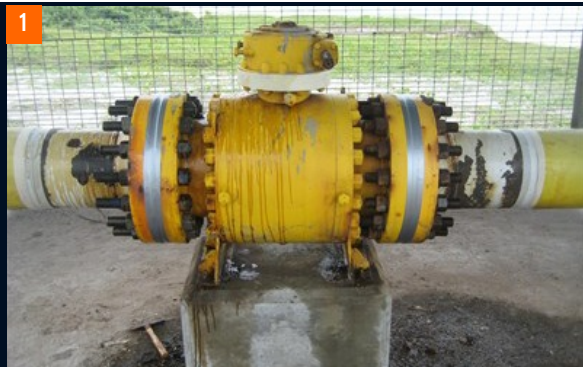
1. Surface preparation 2. Application of the first beige layer of Belzona 3411 in progress 3. Application of the second grey layer of Belzona 3411 4. Application of the Belzona 3411 on the 3" flanges

Application was carried out in accordance with Belzona System Leaflet GSS-11. The Belzona protection system was applied by brush without the installation of plastic caps. This does not affect the corrosion resistance of the system.
