# BELZONA SUPERWRAP II PROTECTS UNDERGROUND PIPELINE

ID: 7471

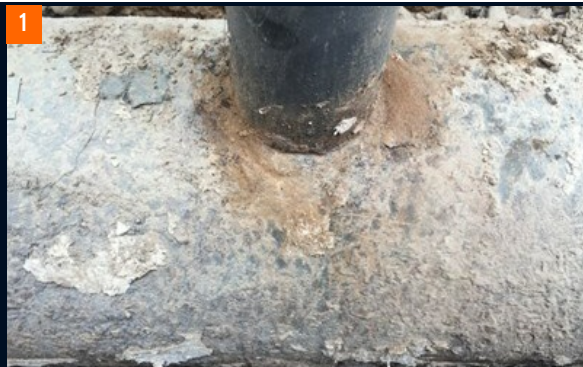
The pipe external wall had corroded due to the long-term humid environment. Pitting corrosion had led to significant wall thinning.

1. Severe corrosion in the thinned-wall
2. Surface preparation underway
3. Application of Belzona SuperWrap II
4. Application completed
