# BELZONA QUICK EFFICIENT SOLUTION FOR FACTORY FLOOR

ID: 7472

A synthetic sausage skin factory had numerous floor problems in the process area.

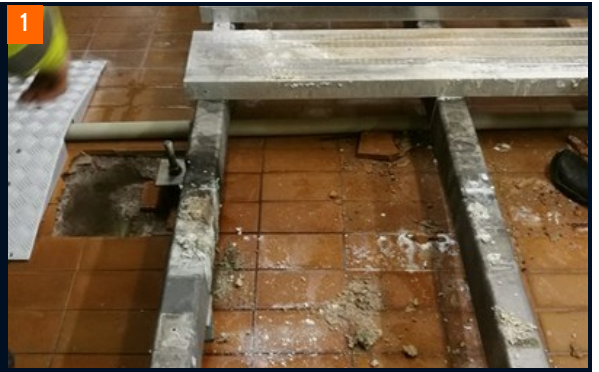
Chemicals were damaging the floor and attacking the grout between tiles. This particular problem area was a 3-4m<sup>2</sup> area underneath equipment with leakages. The repair had to be carried out in a 3 day window.

1. Damaged tiles under equipment
2. Belzona 4154 applied to infill deepest damage
3. Application of Belzona 4111 to restore original levels
4. Belzona 4311 coating applied for chemical resistance
