# BELZONA SUPERWRAP II APPLICATION AVOIDS WATER SUPPLY INTERRUPTION

ID: 7479

Potable water pipes at pumping station.

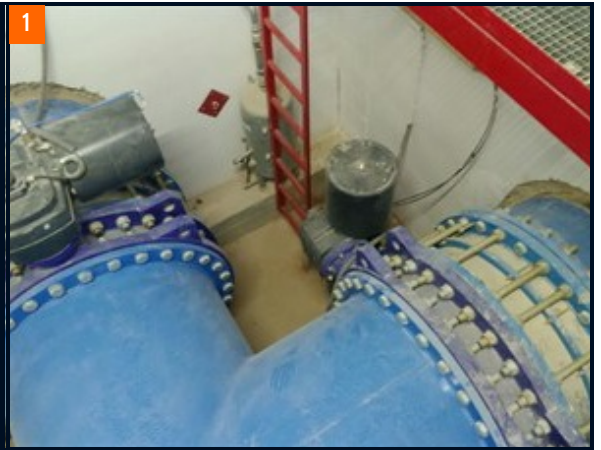
Several pipes were suffering from significant external corrosion due to water leaks occurring through the sealing system between the pipes and the concrete walls of the tanks.

1. Potable water pipes of 1300mm diameter to be repaired 2. Surface preparation by grit blasting completed 3. Application of the Belzona Superwrap system underway 4. Job completed
