# PUMP SUMP PROTECTION WITH BELZONA ON OIL TANKER

ID: 748

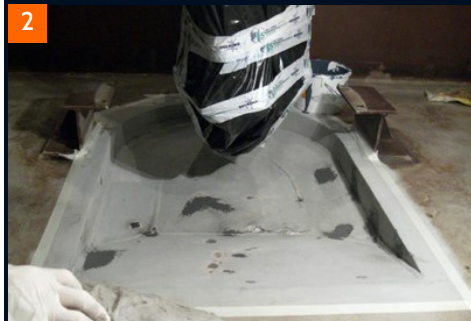
Erosion/Corrosion due to the constant liquid flow over the sump during cargo transfer.

1. The tanker in dock.
2. Sump after blasting.
3. Sump coated with Belzona 1391.
4. Completing the application.

Application was carried out in accordance with Belzona Know-How System Leaflet TCC-5.
