# IMPELLER RESTORATION WITH BELZONA KEEPS BIOMASS PRODUCTION ONLINE

ID: 7482

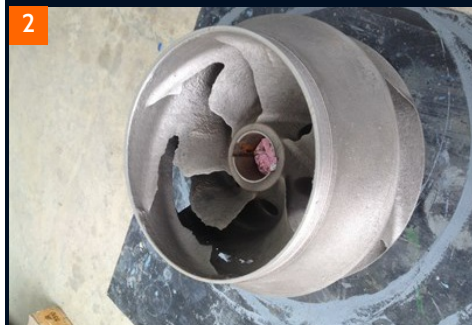
As part of their operations, they needed to restore three damaged pump impellers. In order to eliminate the growth of any microbiological matter which could affect the algae's development or quality, the producer uses strong chemicals to clean the process equipment. Each pump is cleaned every one to two weeks. The frequency of this cleaning had resulted in the pump impellers becoming damaged after just one year in service.

1. Three impellers damaged in 2014
2. Grit blasted impeller highlights the extensive damage
3. Shape restored using wire mesh and Belzona 1311
4. Impellers still in perfect condition in 2017

Application completed in accordance with Belzona System Leaflet CEP-1 and CEP-3. The eroded impeller design was rebuilt using a combination of wire steel mesh and Belzona 1311. Once the shape was restored, the impellers were coated using Belzona 1321 to protect from further damage.
