# SO-CALLED "UNREPAIRABLE" PUMPS RESTORED WITH BELZONA

ID: 7483

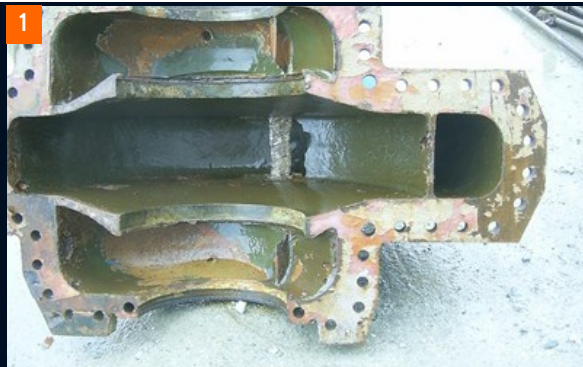
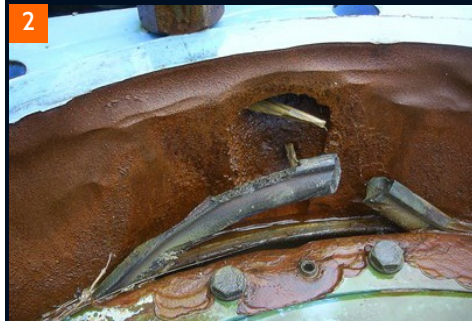
The pumps had to work 24 hours per day for a continuous period of 5500 hours (approximately 229 days). They were experiencing serious corrosion and some erosion from the cascade of return water from the dam containing active chemical reagents (pH from 2.5 to 8), as well as a small amount of solids.

- 1&2. The corroded pumps  
3. The Belzona application underway with Belzona 1311 used to restore original profiles  
4. The completed application with Belzona 1341 applied to provide overall corrosion protection

Application was carried out in accordance with Belzona Know-How System Leaflets CEP-1, CEP-2 and CEP-3. 104 kilos of Belzona 1311 and 22 kilos Belzona 1341 were used.
