# BELZONA PROTECTS BLADES EFFECTIVELY AGAINST ABRASIVE PULPS

ID: 7485

Pulp-agitator blades in the chemical section of the phosphate mine.

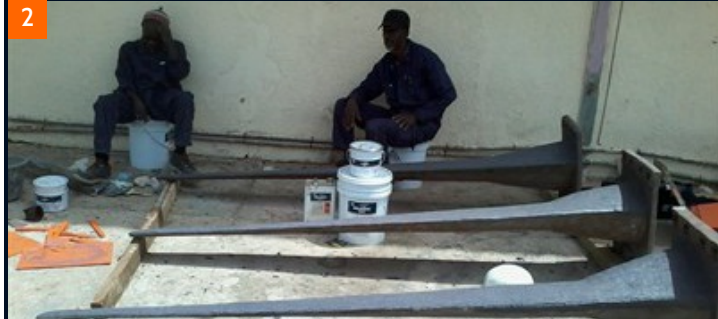
1. Initial repair by welding.
2. Blades protected with Belzona 1812
3. Blades inspected after 12 months in service

After removing the remainder of the rubber coating, the blades were welded on the heavily damaged areas. The surface was then grit-blasted before the application of Belzona 1812 according to the SHM-13 Belzona procedure.
