# BELZONA PROTECTS SCREW CONVEYOR AGAINST ABRASION

ID: 7486

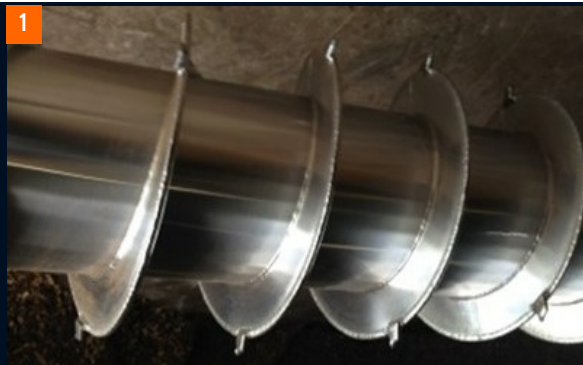
Abrasion of welds. Welding of the screw every 12 months. Service life: 5 years

1. Grit-blasted screw conveyor
2. Application of ceramic tiles on Belzona 1311
3. Finished application

The surface was grit-blasted and a layer of Belzona 1311 was applied. Ceramic tiles were placed and coated with Belzona 1311. The surface was then grit-blasted and Belzona 1341 was applied in 2 layers.

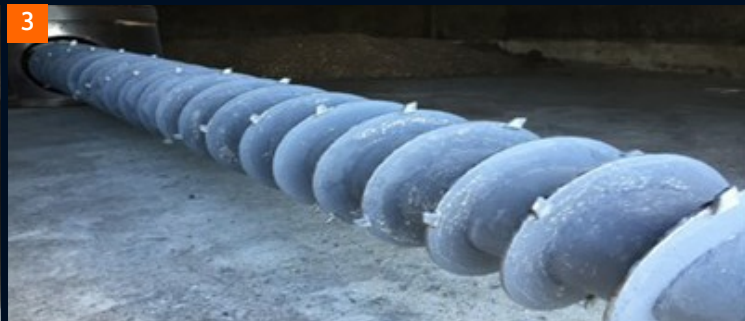
Visit after 12 months: no visible abrasions or tile detachment
