# BELZONA PROTECTS RAIL CARRIAGE ROOFS

ID: 7487

Roof on railway carriage

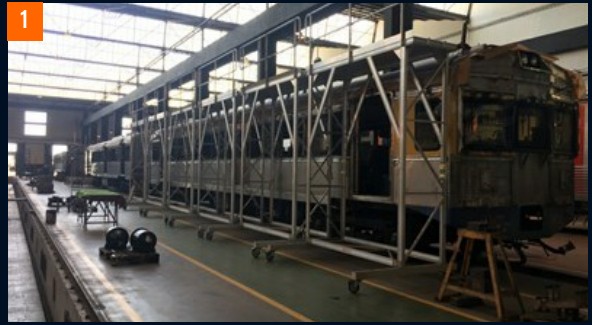
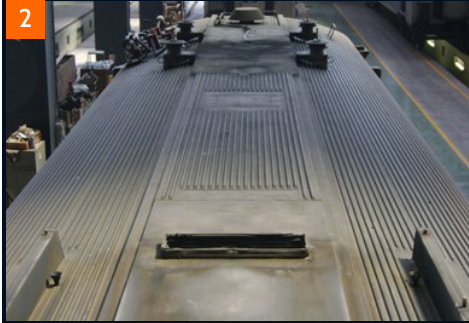
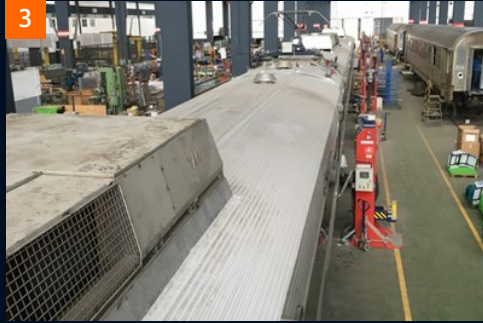
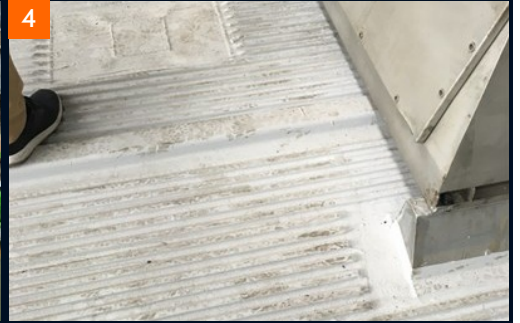
Water leaks on the roofs due to presence of small cracks and holes made to install specific furniture.

After conditioning the substrate with Belzona 3921 (GSC Conditioner), a fully reinforced Belzona 3111 system (including Belzona 9311 reinforcement sheet) was applied to the entirety of the carriage roof. The application was carried out in accordance with Belzona Know-How System Leaflets RPA-01 & RPA-08.
