# BELZONA PROVIDES EROSION CORROSION PROTECTION TO ORE THICKENER

ID: 7491

Thickener used to dewater gold containing ore.

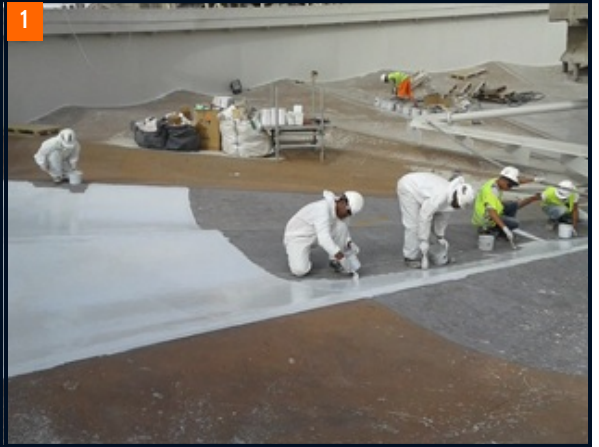
1. Application in process
2. Inspection of Belzona 1331
3. Thickener fully protected with Belzona 1331
4. Thickener in service after completion of the application.

The coating was applied to the entire thickener according to the Belzona Know-How System Leaflet TCC-5.
