# BELZONA KEEPS THE TANK AFLOAT!

Floatation tank operating at 90C, in contact with produced water.

Offshore oil production platform, Gabon

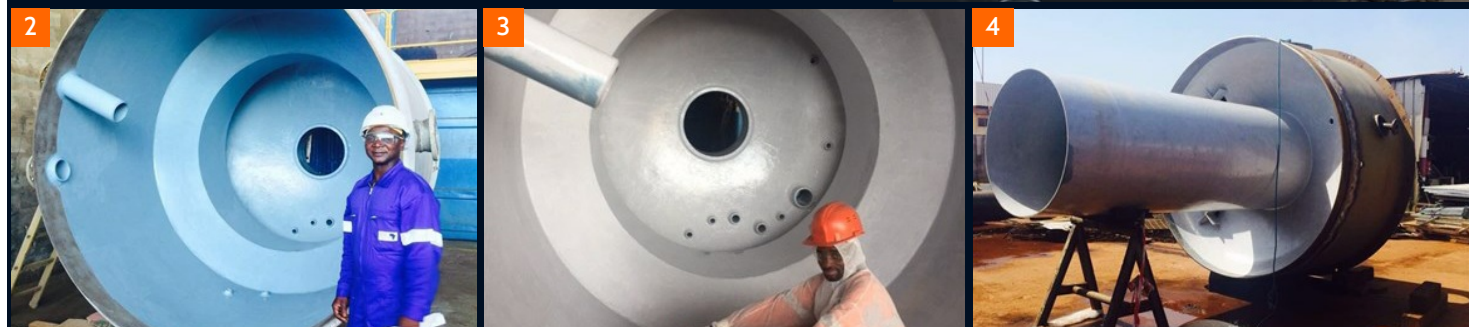
The original coating had failed in most areas. Pitting on the bottom head and on the shell manway was of particular concern.

1. View of the tank
2. First coat application completed on the shell
3. Second coat application in progress
- 4- Second coat application completed on the inner part of the tank

Application was carried out in accordance with Belzona Know-How System Leaflet TCC-5.

Belzona 1391T has been selected for its corrosion resistance in an immersed environment at high temperatures, offering long term protection for the oil operator.
