# BELZONA SUPERWRAP REPAIRS VESSEL NOZZLES ONLINE

ID: 7495

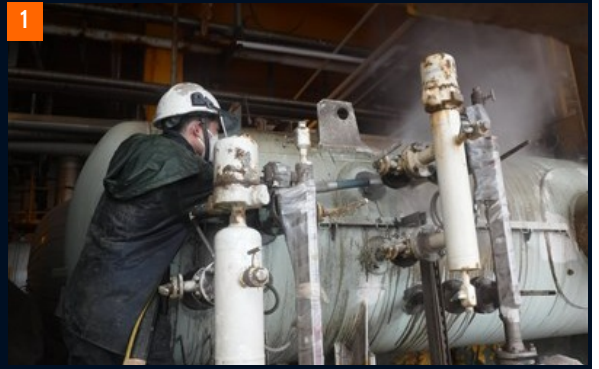
1. Vapor blasting 2. Nozzle after vapor blasting 3. SWII application 4. SWII applicataion finished

SWII was designed and applied according to ISO 24817 standard. The explosion-proof vapor blasting was taken for surface preparation. VPF-11 was followed.

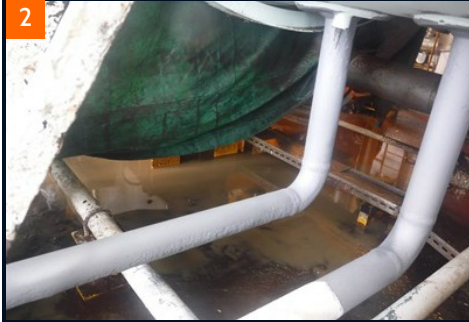
Offshore platform vessel nozzles were corroded by CUI, and some small bore nozzles were leaking.
