# SAVING THE BELT WITH BELZONA!

ID: 7497

2 - 50" Conveyor belts lifting grain from rail cars to silos.

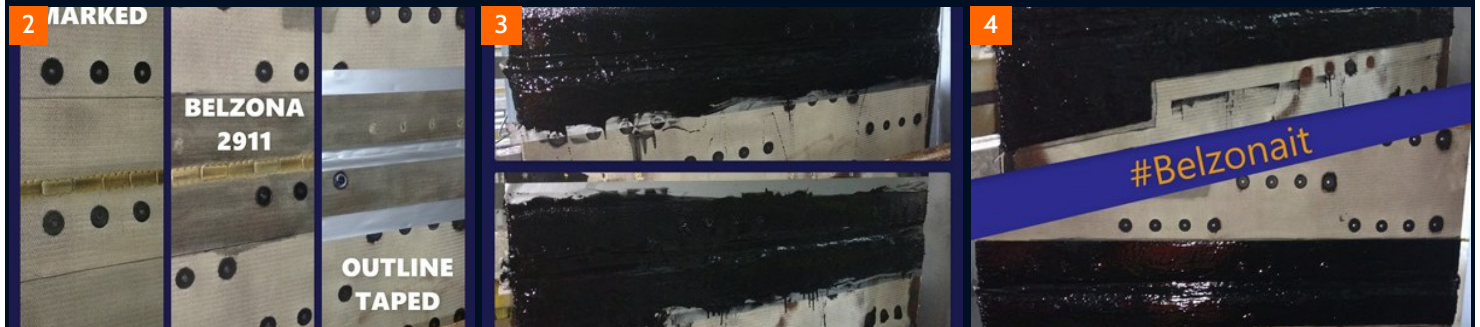
Corn and soybeans falling as the conveyor belt lifts the grains up was causing enough abrasion on the backside of this vertical belt to wear off a complete layer of rubber leaving the layer of the fiber exposed. The wear is worse right next to the joint actually wearing through the fiber layer.

1. The silos. 2. Belt prep and Belzona 2911 QD Conditioner. 3. First layer of Belzona 2111 D&A Hi-Build Elastomer. 4. Application complete.

Pressure washed the application area to remove debris and grain dust. Used a handheld wire brush to roughen the fiber surface as the majority of the rubber layer was loose and disbonded and was removed. The outline of the proposed application area was marked and the Belzona 2911 QD Conditioner was applied and allowed to dry per the IFU. Duct tape was applied over the joint seam to allow the application to bridge rather than adhere. The outline was also taped off just inside of where the conditioner was applied. Only one unit of Belzona 2111 D&A Hi-Build Elastomer was mixed at a time, the first batch used to wet out the application area, the second added some volume as well as wetting out the Belzona 9341 Reinforcing Sheet. The last batch smoothed out the application and covered the reinforcing sheet completely.

Only 3 units of Belzona 2111 D&A Hi-Build Elastomer were used on this project. The alternative is to replace the belts which reach over 10 stories straight up and would cause extended downtime. This repair took 4 hours and will protect the belt from the highly abrasive grain.
