# MULTIPLE BELZONA REPAIRS TO 72" DIAMETER STEEL PIPE EMBEDDED IN CONCRETE

ID: 75

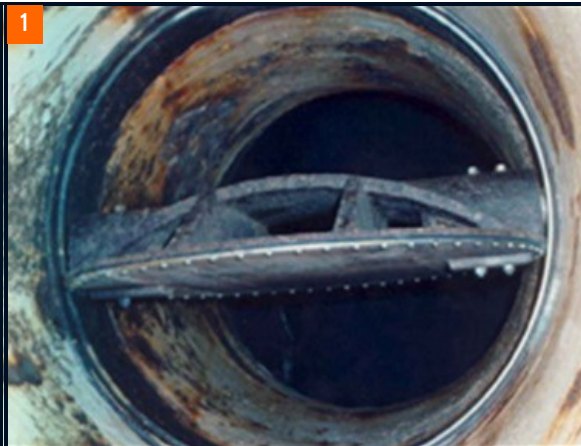
The 72" diameter steel pipe embedded in concrete was corroded and had developed through wall leaks.

1. View of the eroded pipe before work commenced
2. Completed application to steel pipe
3. Overall view of repair area showing patch repairs to concrete pipe and application to steel pipe in background

Application was carried out in accordance with Belzona Know-How Leaflets VPF-1, VPF-2 and FPA-6.
