# BELZONA REBUILDS AND PROTECTS A KORT NOZZLE

ID: 750

Kort nozzles of large self propelled marine log loader

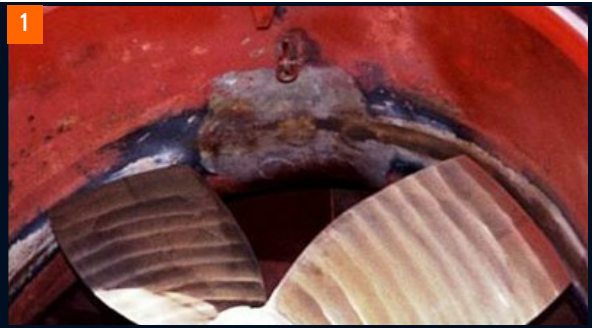
Erosion-Corrosion of inner circumference of kort nozzles.

1. View of port side nozzle showing erosion pattern after three years service.
2. View of starboard side nozzle after three years of service.
3. Re-application of Belzona 1341 to complete nozzle after welding had been completed to close various cracks.

The application shows the vessel in drydock for its three year overhaul. Pictures show how well the Belzona coating has protected the nozzles from excessive erosion-corrosion over this period.
