# BELZONA SEALS WIND TURBINE TOWER BASE AGAINST WATER INGRESS

ID: 7500

Wind Power Tower Base

Wind Farm, West Texas, USA

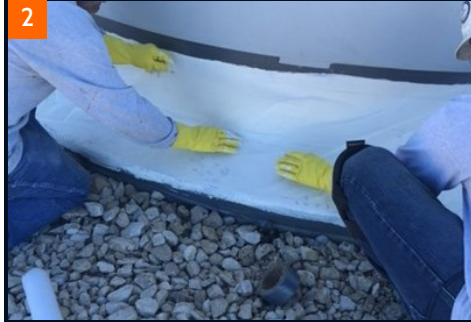
Rain water and moisture seeps into the ground and into the wind turbine structure through the base around the tower structure. This over time affects the concrete base and propagates cracks and corrosion at the base of the tower. In this case the current coating failed due to UV degradation leading to delamination from the concrete surface.

1. The old coating that failed, yellowing and peeling from the concrete surface.
2. The application area being outlined.
3. Application of Belzona 3111 underway.
4. Application completed and tower base sealed with Belzona 3111.
