# BELZONA REPAIRS AND PROTECTS CYANIDE CONTAINMENT AREA

ID: 7501

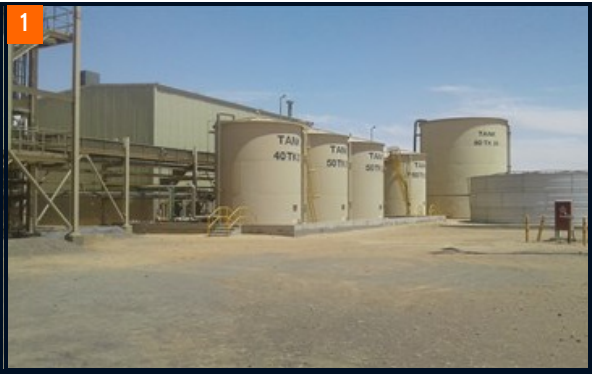
1. Chemical storage tanks area. 2. Application of Belzona 4131 to walls and concrete plinths in progress 3. Containment area rebuilt and protected with Belzona 4131
