# BELZONA SEALS OIL LEAK IN CONCRETE RESERVOIR IN WIND TURBINE TOWER

ID: 7503

Oil Reservoir Within Wind Turbine Tower

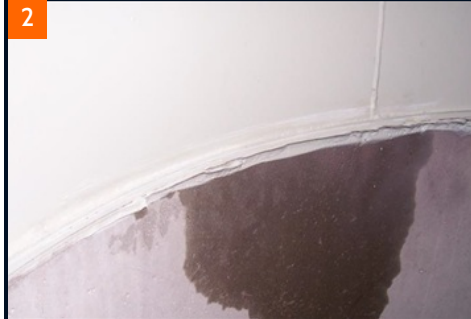
Oil Reservoir located circularly around the wind turbine tower is leaking at the bottom through the concrete and treads into the sealing under it. The oil is being lost and some concrete loss/damage has been sustained over time because of the leaking.

1. Oil reservoir built around the wind tower.
2. Oil leaking under the reservoir through to the concrete.
3. Surface preparation for the repairing of the damaged concrete with Belzona 4141 and Belzona 4911.
4. Oil reservoir sealed with Belzona 1321.

The application was carried out in accordance with a modified version of Belzona System Leaflet TCC-1. The oil was emptied out, the area in the reservoir and under it in the lower floor sealing was thoroughly cleaned. The damaged concrete area was rebuilt with Belzona 4141 using Belzona 4911 for proper adhesion. Belzona 1321 was then poured into the reservoir up to 4 inches from the bottom to seal off any leaks from the concrete or treads to the sealing below.
