# COLD PLATE BONDING AND TRADITIONAL COMPOSITE WRAP RESTORES DISCHARGE PIPE

ID: 7504

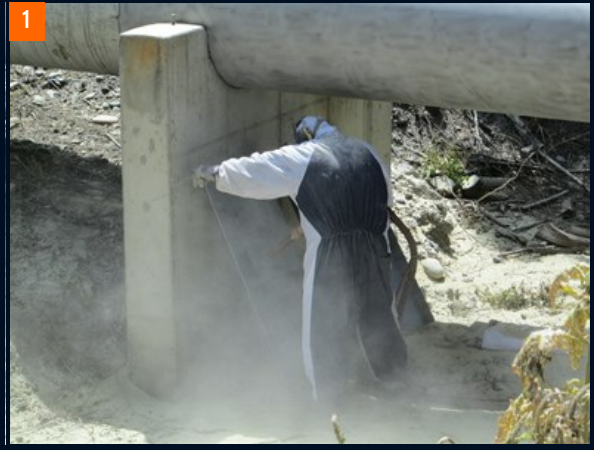
Years of pumping salty river water eroded this discharge pipe which feeds an irrigation ditch. The severe reduction in wall thickness resulted in numerous failures. The pipe was too thin to weld, and being roughly 30" in diameter, a repair was more conducive to the exposed exterior than on the inside.

1. Surface preparation of saddle plates and pipe
2. Some of the numerous plates cold bonded in place
3. Second wrap of the composite repair prior to application of an UV protection third coat
4. 33 feet of pipe length completed and painted to withstand ultraviolet light exposure

A modified Belzona System Leaflet VPF-11 was used. The pipe was already riddled with large through-wall defects, and after abrasive blasting the pipe, numerous small holes developed. These small holes were repaired with Belzona 1111 reinforced with Belzona 9341. The larger holes were repaired using a plate cold bonding technique. The adhesive used was Belzona 1121 due to its extended working life. A two-wrap traditional composite system, consisting of Belzona 5811 reinforced with Belzona 9331, was applied. A third coat was used to fully encapsulate the reinforcement sheet. A final paint was used to prevent UV degradation.
