# PARKS AND RECREATION RESTROOM FLOOR COATED WITH BELZONA

ID: 7505

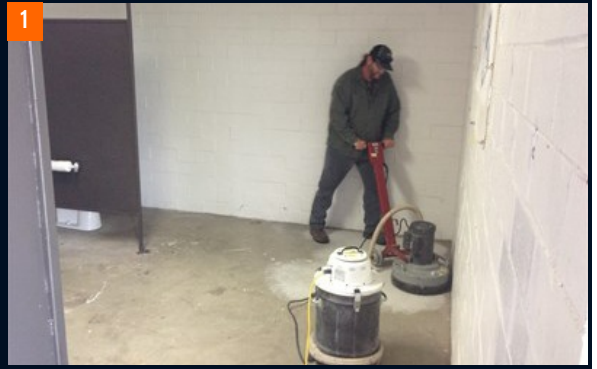
1. Performing floor grinding preparation
2. Surface edge and floor grinding complete
3. Belzona 5811 application complete

The application was carried out in accordance with a modified version of Belzona System Leaflet FPA-3. The floor was ground with diamond grinders. Within the overcoat windows two full coats of Belzona 5811 were applied.
