# BELZONA KEEPS THE WATER ON THE OUTSIDE OF THE TUGBOAT!

ID: 7507

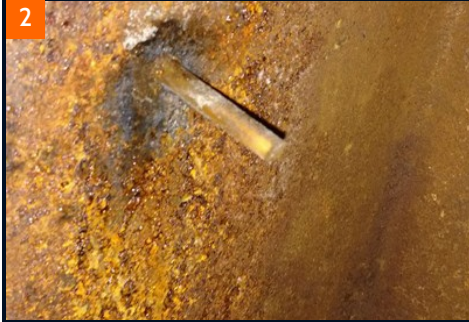
Corroded steel hull developed leaks. The initial response was to insert a wooden dowel into the 1/2" hole. The hole is over 10' below water level on this tugboat. The wooden dowel stopped most of the water but still had some wetness seeping through.

1. Three of the companies tugboats at dock.
2. The dowel plugging the hole in the hull.
3. Grinding the rust and corrosion off.
4. The complete application of Belzona 1212.

The application was done following Belzona System Leaflet SOS-20a. A grinder was used to remove all of the rust and corrosion from an 8" square. This left a very rough and pitted but clean surface. The grinder was also used to cut the wooden dowel off flush with the hull. There was still some saltwater seeping through, so Belzona 1212 was used due to its surface tolerant properties. A 6" square plate was also cleaned and roughened with a grinder. One unit of Belzona 1212 was mixed and scrubbed in with a short bristle brush to both the hull and the plate. The remaining Belzona 1212 was applied to the center of the steel plate and firmly applied to the prepped area of the hull until the excess material was compressed out of all four sides. The edges were then smoothed off.
