# BELZONA PROTECTS SCREW AUGER FROM ABRASION AND CHEMICAL ATTACK

ID: 7508

Screw Auger

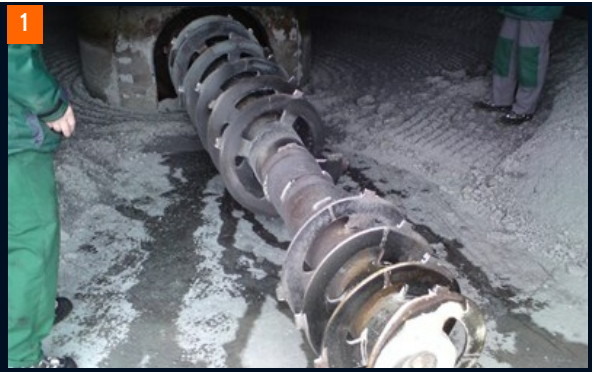
A coating was needed on to protect a screw auger against abrasion and chemical attack.

1. Before the application
2. Before the application (close up)
3. After the application
4. 8 years later

After surface preparation, Belzona 1811 was applied to protect against abrasive attack and Belzona 4311 to protect against chemical attack.
