# BELZONA REBUILDS AND PROTECTS KORT NOZZLE

ID: 751

Tug boat kort nozzles

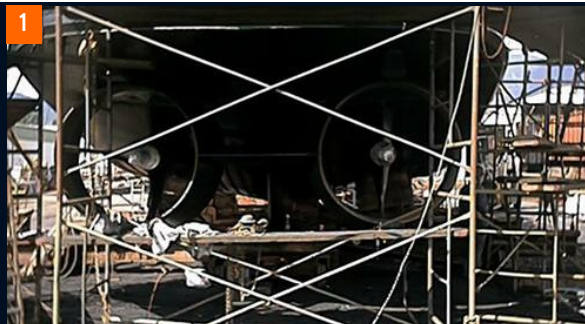
1. View of tug boat in dry dock
2. First coat of Belzona 1321 applied before the damaged areas were rebuilt with Belzona 1311
3. Completed application

This vessel had originally been repaired and protected with Belzona in 1996 and much of the coating was still in place five years later. Because of corrosion from the inside sections of the nozzles they needed to be replaced. Once this was completed customer insisted that the welded areas be faired in with Belzona® 1311 and the nozzles protected with Belzona® 1321.
