# BELZONA FIXES INTERNATIONAL AIRPORT TERMINAL FOUNTAIN

ID: 7510

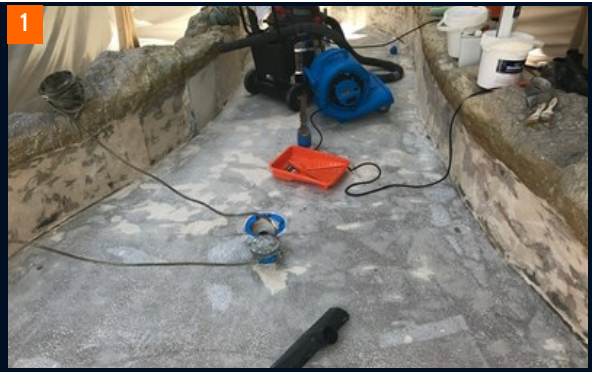
- 1) Terminal A fountain on first site visit. The other attempts at repairing with foam injection and concrete patches is visible
- 2) A picture of the adjacent side walk that has gotten wet but is shown dry in the picture because the client has shut the fountain down. After the waterfall runs for a couple hours, the sidewalk starts to puddle with water that accumulates
- 3) Application of Belzona 4124 bulkfill under the overlaying rock face
- 4) The waterfall after running at full operation for 3 weeks with ZERO water accumulation on the adjacent side walk
