# BELZONA PROTECTS NEW BUILD FLARE STACK

ID: 7514

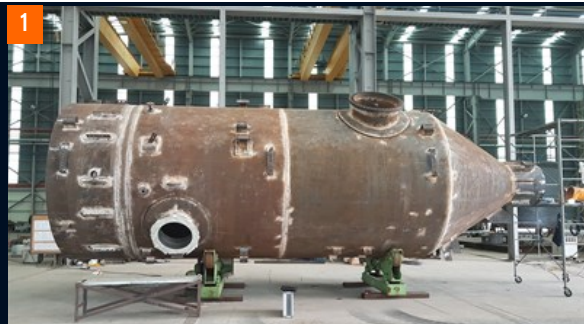
1) Overall View of Flare Stack 2) Blasted Area 3) Applying Belzona 1391T 4) Completed Coating
