# BELZONA REBUILDS AND PROTECTS KORT NOZZLES

ID: 752

Kort nozzles badly eroded.

Tug boat kort nozzles

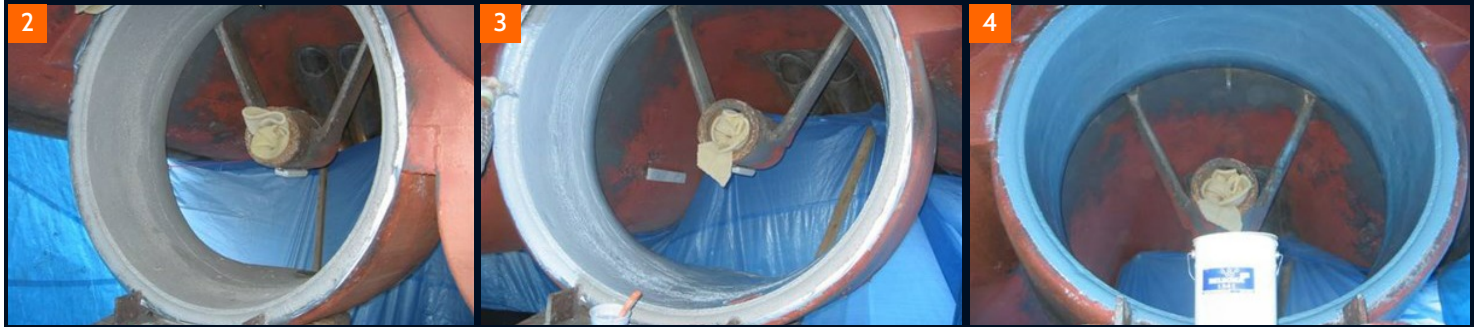
1. View of tug boat in dry dock.
2. View of one of the blasted nozzles.
3. Application of first coat of Belzona 1341 with application of Belzona 1311 to fill the voids and depressions in progress.
4. Second coat of Belzona 1341 applied to complete the application.

Application was carried out in accordance with Belzona Know-How System Leaflets SOS-1 & SOS-2.

Customer had given serious consideration to relining nozzles with a stainless steel insert. This, however, posed a clearance problem. The Belzona solution was the quickest, easiest and most economical solution of the two.
