# BELZONA COATS FILTER SCREENS FOR A HYDRO DAM

ID: 7523

Red Rock Hydroelectric Dam Iowa

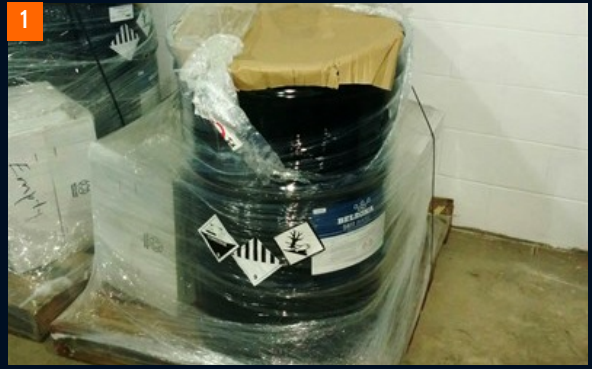
1. 5811 ready for use 2. Filter Screen to be coated 3. Screen being coated 4. Finished Filter screens coated with 5811

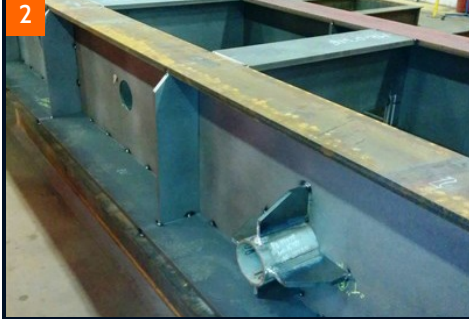
Filter Screens filter debris sizes from the river to acceptable size that can go into the Hydro-power energy production process. Corrosion and impact from sedimentary debris deteriorated the gates over time letting in debris size hazards to the process and equipment.
