# BELZONA SUPERWRAP II SUCCESSFULLY TACKLES AN EMERGENCY PIPE LEAK REPAIR

ID: 7525

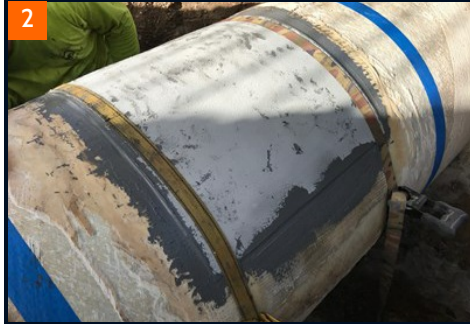
Rupture in the water pipe line causing erosion of the surrounding area and the road above the line.

1. Rupture in the water pipe line. 2. Metal plate bonded with Belzona 1212 to create a bridge for the wrap. 3. Wetting out Belzona 9381 (reinforcing wrap) with Belzona 1982 (resin). 4. Complete application of the Belzona Superwrap II composite repair system.

First, the rupture had to be opened wider to pump out all of the water from the pipe. The surface was then blasted to prepare the right profile to ensure optimal adhesion with the Belzona products. Due to the size of the rupture, a metal plate was used to bridge over the rupture. Belzona 1212 was used to bond the plate to the substrate. Belzona 9381 (reinforcing fabric) was then wetted out with Belzona 1982 and wrapped around the circumference of the pipe. Belzona 9382 (release film) was then applied over the wrap to secure it in place and to avoid air entrapment by exuding excess resin.
