# BELZONA SHAFT REPAIR PREVENTS LOSS IN REVENUE

ID: 7526

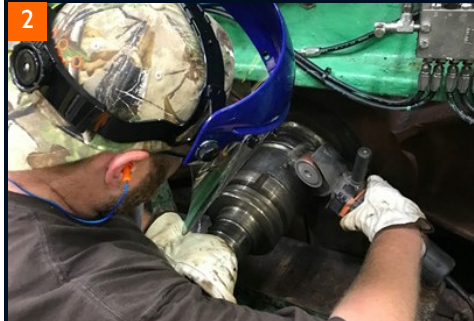
Bearing failure had caused significant damage to the main drive shaft on carton forming machine. Replacing shaft would take up to 21 days of round-the-clock work.

1. Damaged shaft.
2. Preparing the repair area with a bristle blaster.
3. Former injected with Belzona 1321.
4. Completed repair.

The shaft repair was carried out in accordance with Belzona System Leaflet MPT-2. A custom former had been made at a machine shop. Belzona 9411 was used to make sure that Belzona 1321 would not stick to the former. Belzona 1321 was injected into the former and allowed to cure.
