# BELZONA BOND HATCH FLANGES

ID: 7528

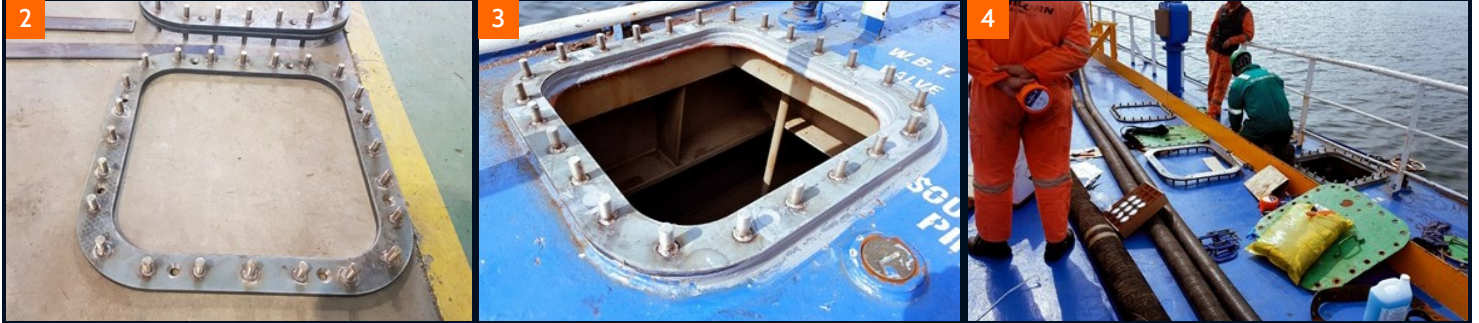
The manway hatches on this vessel had suffered from corrosion damage and began to disbond from the deck.

1. Damaged Hatch Flanges
2. Flanges removed and prepared
3. Hatch rebonded onto the vessel with Belzona 1111
4. Scope of work, all hatches were rebonded.

Hot work was not permitted on the vessel, so Belzona were approached to use cold bonding as an alternative to welding the hatches.

Application was carried out in accordance with Belzona System Leaflet GSS-8. Blasting and grinding was not permitted on the vessel, so a Bristle Blaster was used to prepare the surface and the hatches taken off-site and grit blasted.
