# BELZONA REPAIRS 82 EXPANSION JOINTS ON A PRIMARY SETTLEMENT TANK

ID: 7529

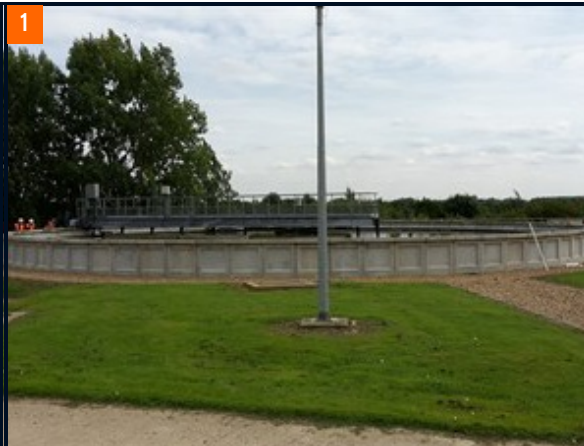
The customer's Primary Settlement Tank was unable to operate efficiently and the tank's arm was struggling to rotate, which could have caused further damage to the equipment.

1. The settlement tank.
2. A damaged expansion joint.
3. Nosings rebuilt using a former.
4. Completed expansion joint.

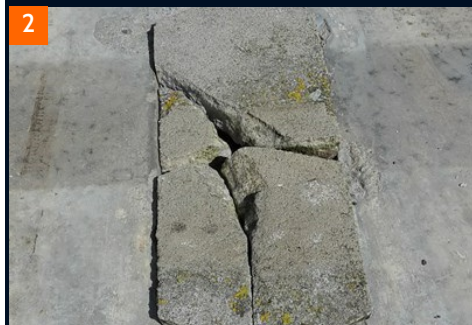
Existing expansion joints had failed. The customer then tried to use a cementitious material to repair them but this also cracked and failed.

The primary settlement tanks' original concrete design failed within four years due to water ingress. Belzona materials are resistant to this type of damage and so will last for many more years to come. This was one of the clients only options to keep the equipment in operation.

The nosings of the joints were rebuilt using Belzona 4111 and Belzona 2211 used as the expansion joint material. The application was carried out in accordance with Belzona System Leaflets FPA-5 and FPA-7.
