# BELZONA SEAL-A-TANK SUCCESS IN SERVICE FOR OVER 13 YEARS

ID: 7530

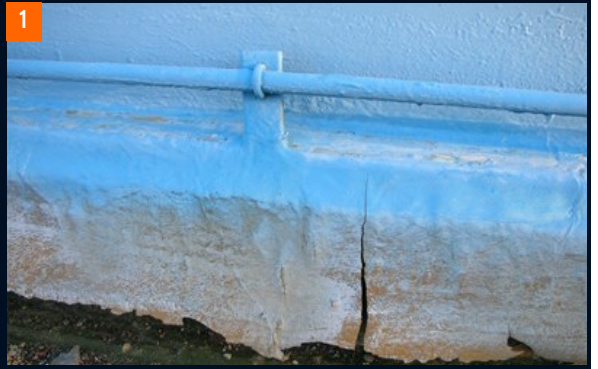
The refinery had an existing tank base sealing system in place which was failing due to its rigidity. The failed system had resulted in water ingress, causing corrosion at the base of the tank and required protection for the long term.

1. Failing system that needed replacing.
2. Surface conditioned.
3. Testing the annular rim through Belzona 3111.
4. Seal-a-Tank system still in an excellent condition.

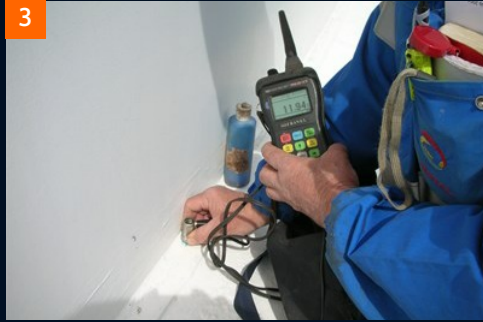
This application was inspected three years after and found to be in good condition with no signs of corrosion. Subsequently, it was reinspected in 2017 and still found to be in excellent condition. The customer was very pleased with the application and its longevity in service. In addition, the customer was pleased because, unlike competitor systems, it is possible to inspect the thickness of the annular rim through Belzona 3111.
