# BELZONA 4301 PROTECTS FLANGE FACE FROM SULFURIC ACID

ID: 7531

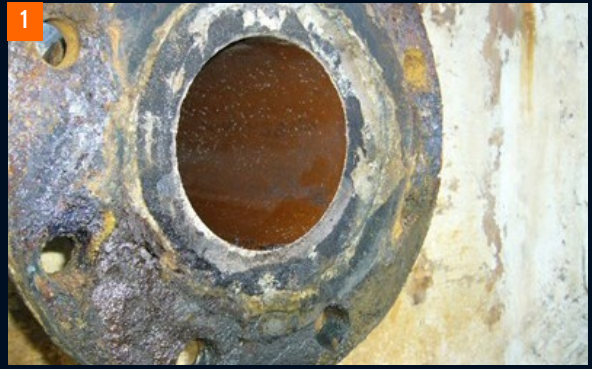
Cutting and welding was deemed to be unacceptable due to the damage that would be caused to the lining inside the nozzle and the safety concerns. A flange face and surrounding bolts had become corroded from contact with Sulphuric Acid. The loss of metal in the flange was causing significant leaks around the flange. This led to environmental and safety concerns.

- 1 - Damaged flange face & bolts
- 2 - Flange prepared & profile checked
- 3 - Former bolted in position
- 4 - Former removed, bore dressed down & induction heat coil in place
