# BELZONA REPAIRS AND PROTECTS WATER SOFTENER

ID: 7533

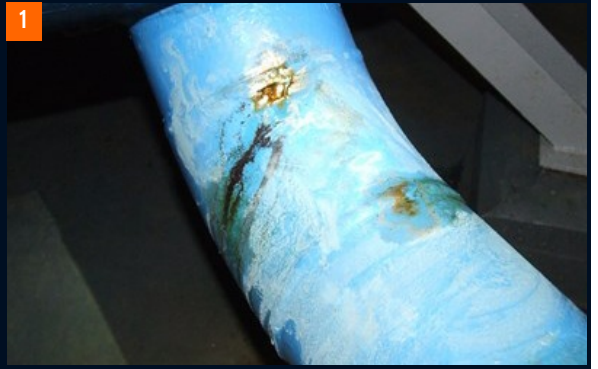
Two welded areas on this pipe had experienced internal corrosion from the internals resulting in pin hole leaks. The water softener contained Brine & ran at approximately 10 degrees C.

1. Leaking area
2. Close up of leak
3. Plate bond & wrap applied
4. Completed application
