# BELZONA REPAIRS A WIND TURBINE SHAFT

ID: 7536

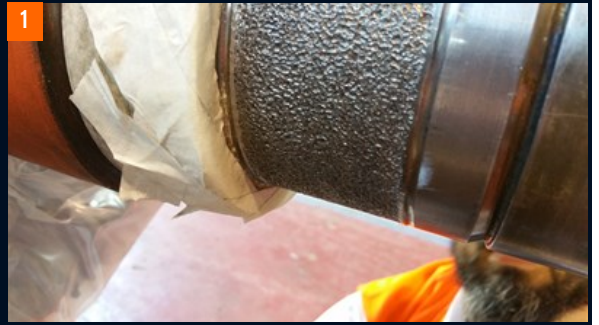
The shafts had become worn, causing metal loss and inefficient operation of components in the nacelle, especially in the seating area of the bearings.

1. Shaft following surface preparation
2. Formers coated with release agent
3. Injection of Belzona 1321 into the mould
4. Shaft rebuilt to exact dimensions

The applications were completed in accordance with Belzona Know-How System Leaflet MPT2. The surfaces were prepared using mechanical hand tools. The pre-designed moulds were coated in release agent in order to allow clean removal of the formers post cure. Belzona 1321 was used to wet out the surfaces of each shaft, prior to the installation of the formers and the injection of the paste-grade into the moulds. After 24 hours, the moulds were removed and the repairs were sanded to exact dimensions required.
