# BELZONA 1212 SEALS LEAKING COPPER GUTTERS AT UNIVERSITY

ID: 7539

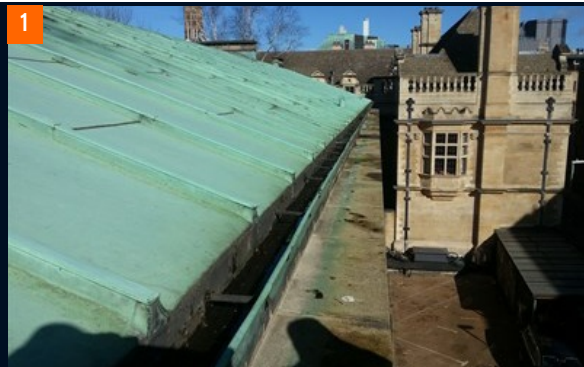
The 56 joints in the copper gutters had been constantly leaking for almost 40 years causing unsightly staining on the building structure underneath the joints.

1.The College Building showing copper gutter and stains on stonework

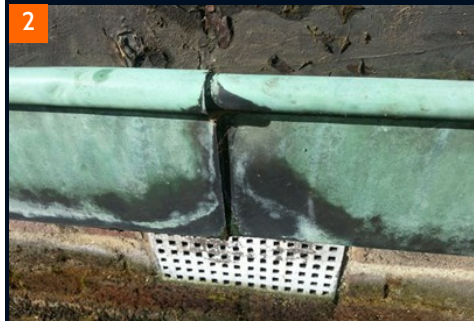
2.Typical leaking gutter joint

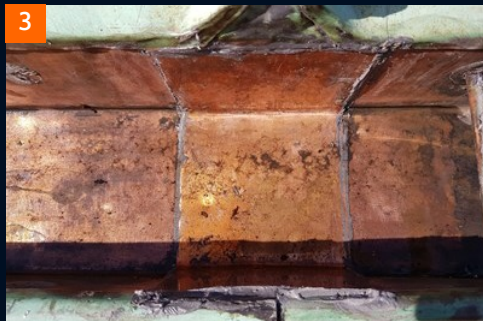
3.Gutter joint cleaned and sealed inside with new copper plate bonded on with Belzona 1212

Application was carried out in accordance with a modified version of Belzona System Leaflet TCC-1. All loose material in the 56 joint areas was removed to create a really clean and bright copper surface. New 200mm copper strips were cold bonded across the joints using Belzona 1212 to permanently seal the joints. Over every 4th joint a flexible system (supplied by the customer) was bonded using Belzona 1212 in the same way.

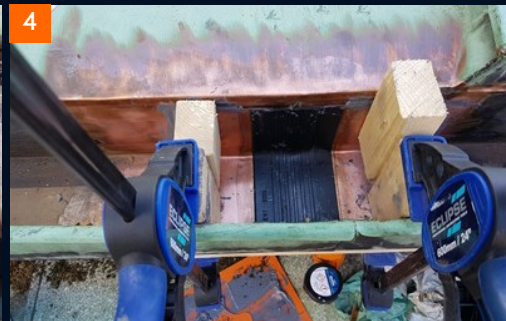
4.Flexible system being installed over every 4th joint bonded on with Belzona 1212
